# Corrosion of Roof Truss Connector Plates in Farm Buildings

## Factsheet

FACTSHEET 16-041 AGDEX 714 AUGUST 2016

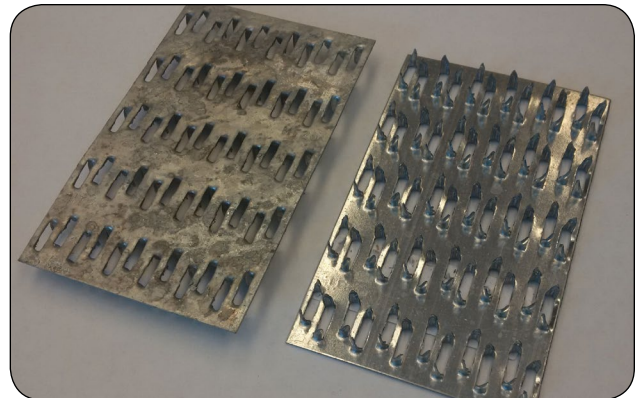
**Figure 1.** Example roof truss connector plates. The plate on the right was fabricated from galvanized sheet steel. The plate on the left was galvanized after plate fabrication.

Some additional protection for limited corrosive environments is provided by using plates with Coating Designation G185. The designer should check with the plate manufacturer or truss supplier to ensure these plates are available and the level of corrosion resistance provided. Since the punching process to fabricate the plates also exposes unprotected edges of the teeth, insist on hot-dip galvanizing the plates after fabrication.

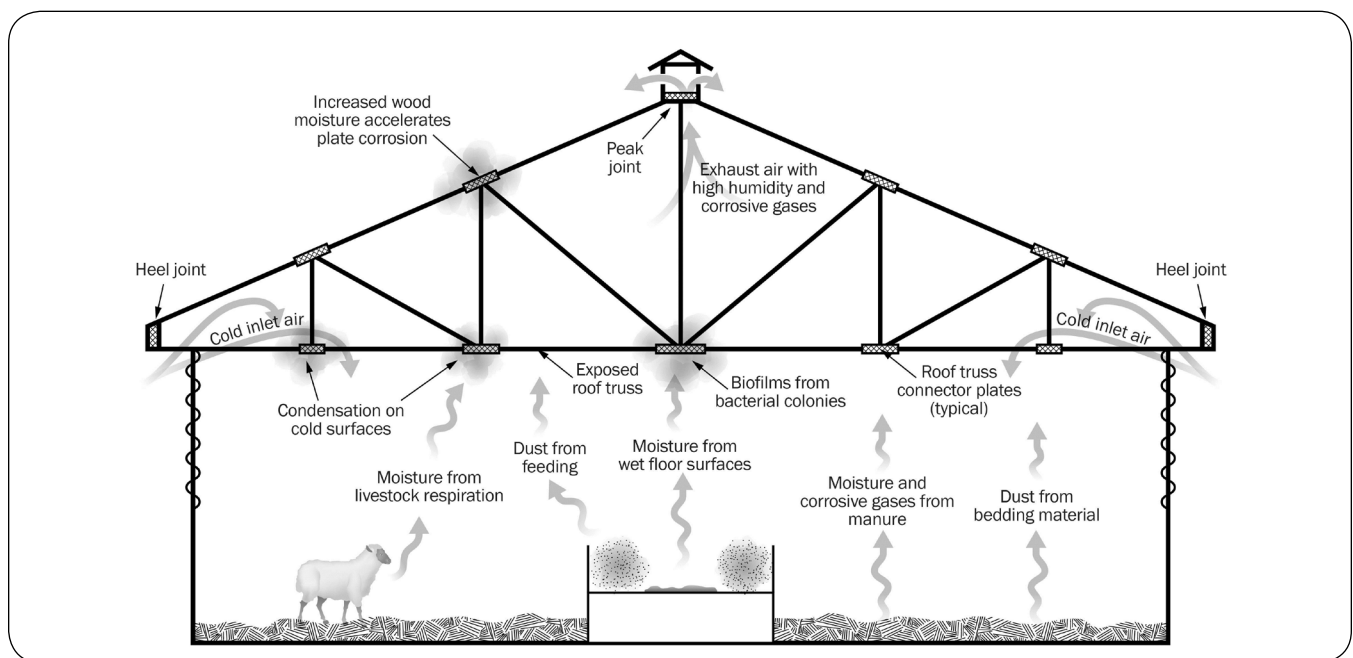
Livestock barns and roofed manure storages without ceilings are often affected by corrosion. These buildings allow moisture, corrosive gases and dust direct access to the trusses and connector plates (Figure 2). The connector plates often show the greatest deterioration near the building air exchange openings, at the heel and peak joints of the truss. These are the areas of significant air mixing and temperature changes, coupled with high humidity and corrosive gas concentrations, producing ideal conditions for corrosion. The heel and peak joints are critical to the structural integrity of the trusses.

**Figure 2.** Sources of moisture, corrosive agents and dust that cause corrosion. This barn has no ceiling, allowing contaminants direct access to the truss and connector plates.
