BROOKS ROAD LANDFILL SITE  
Halimand County, Ontario  
GEOLOGY AND HYDROGEOLOGY ASSESSMENT REPORT  
VERTICAL CAPACITY EXPANSION ENVIRONMENTAL ASSESSMENT  
CROSS SECTION PLAN

18235-20  
Apr 6, 2017

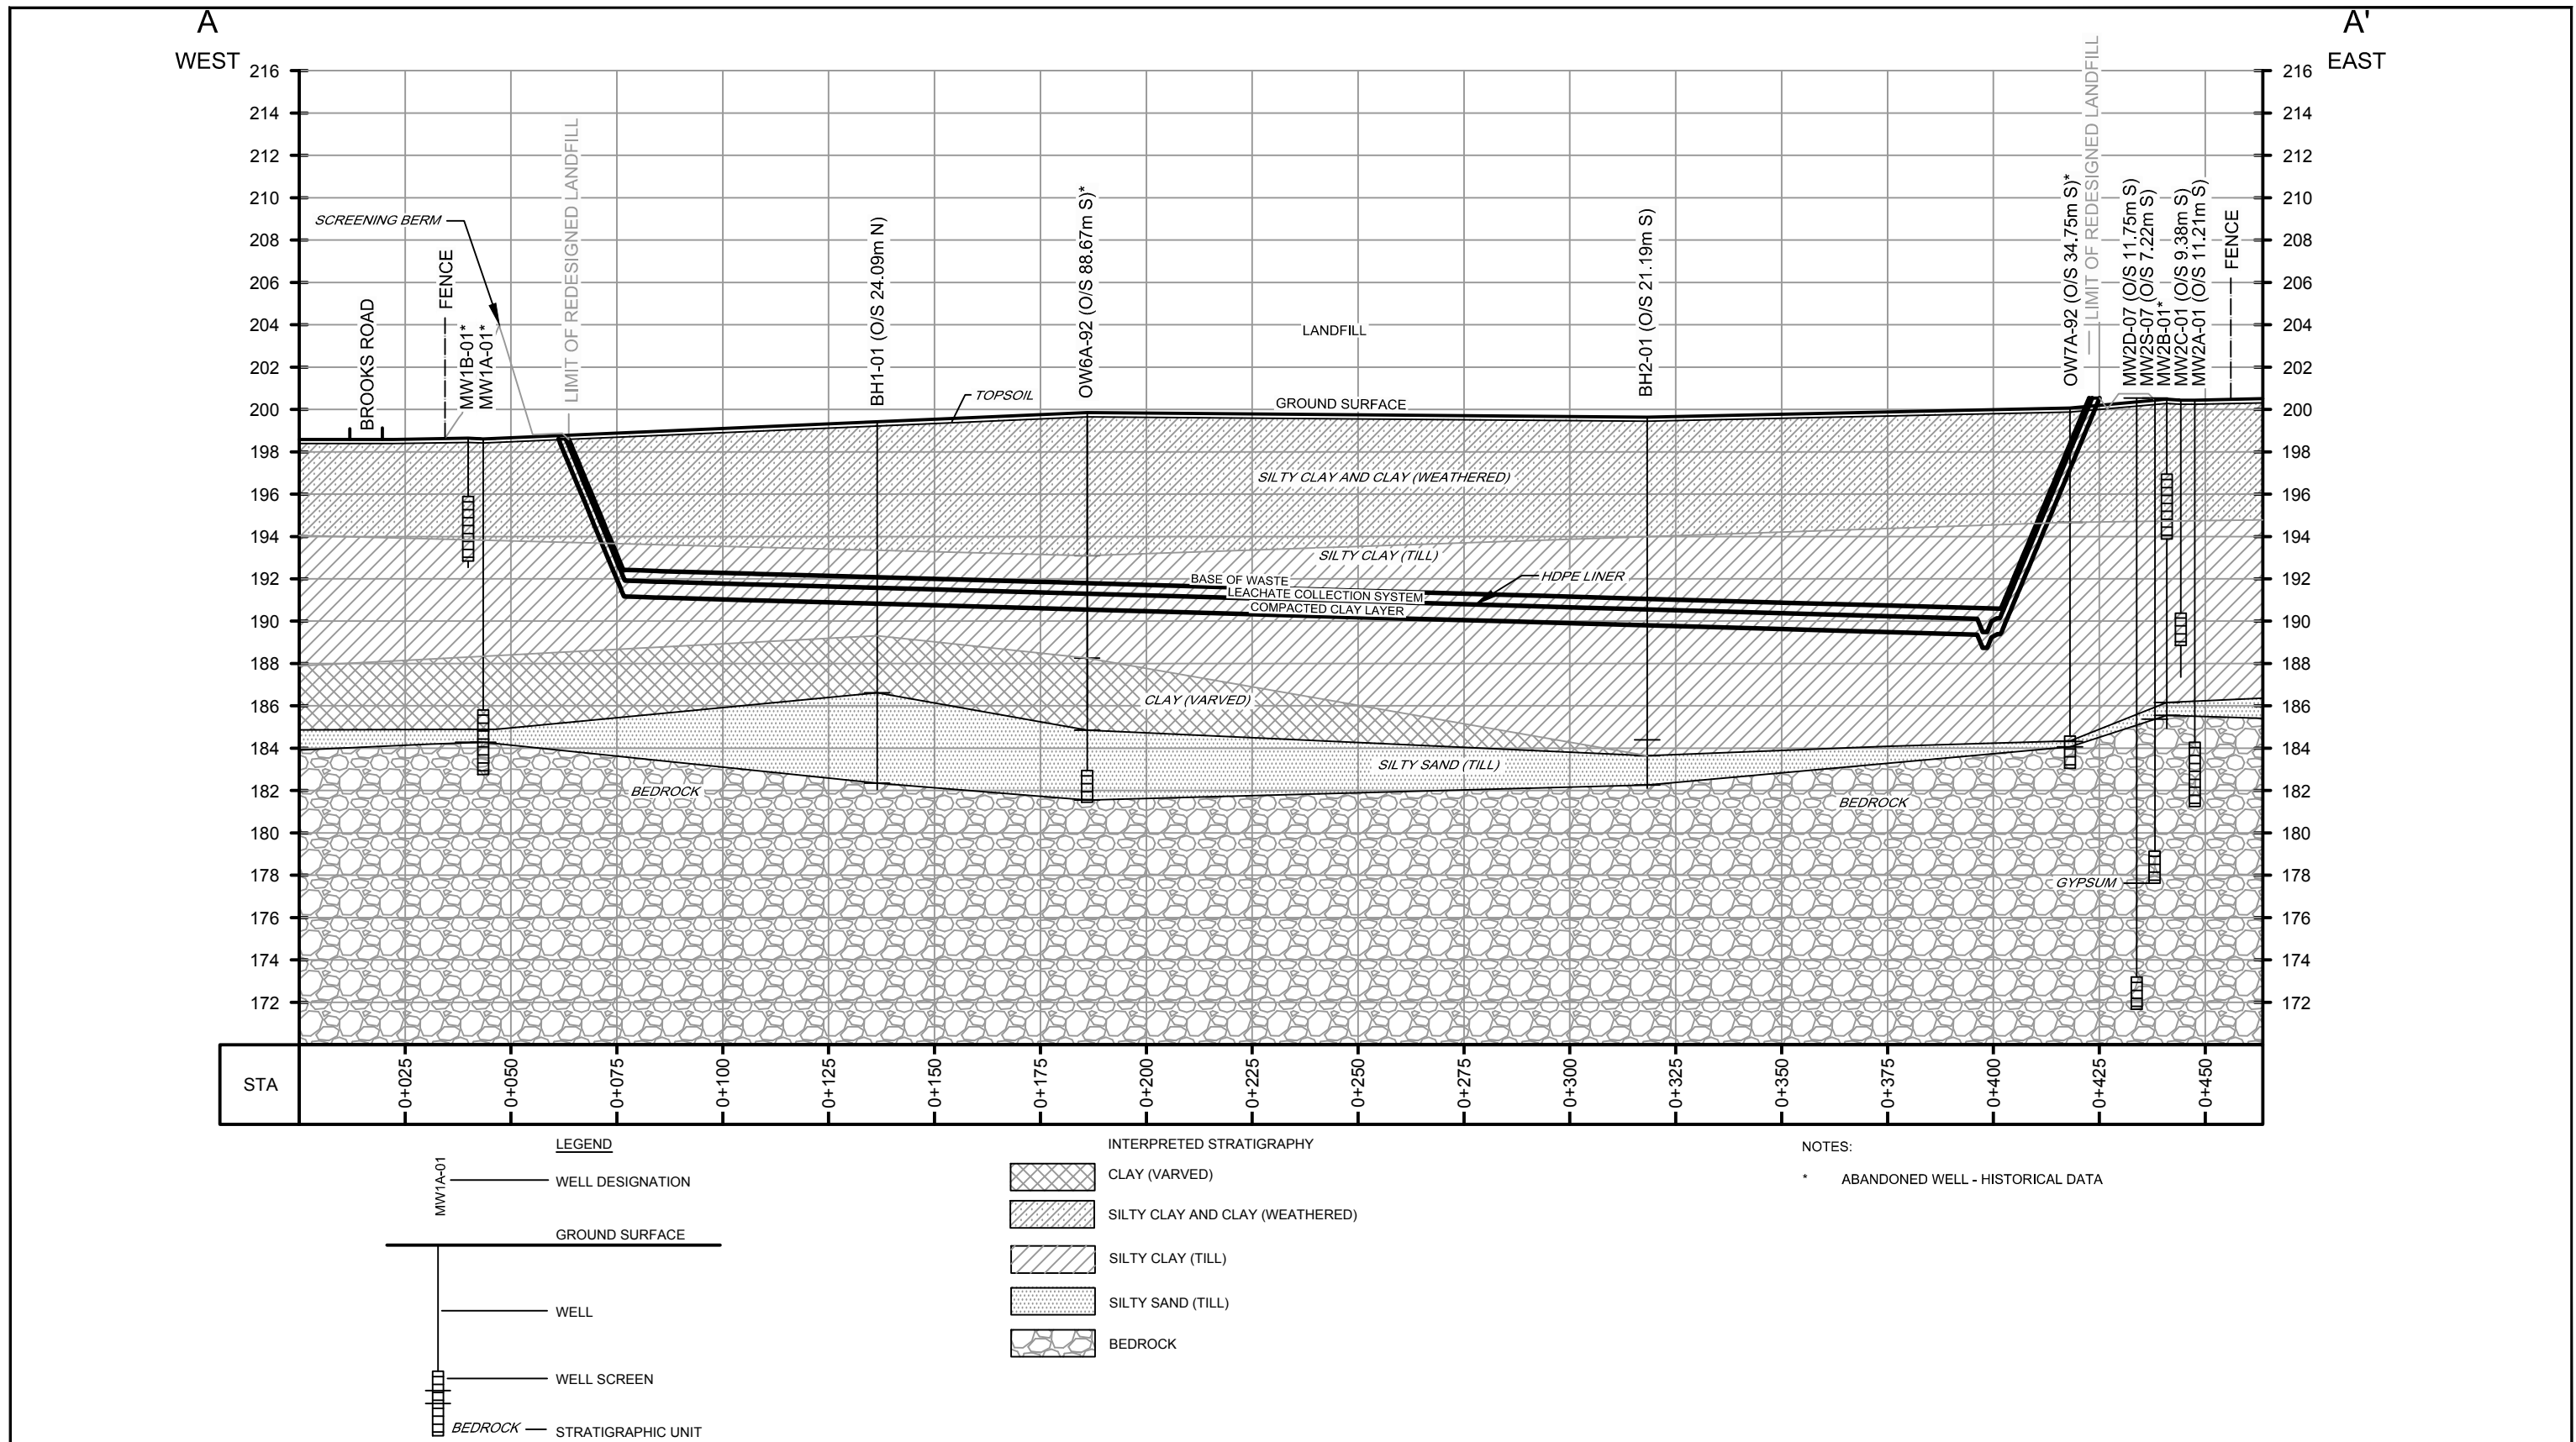
Figure 2

BROOKS ROAD LANDFILL SITE  
Halimand County, Ontario  
GEOLOGY AND HYDROGEOLOGY ASSESSMENT REPORT  
VERTICAL CAPACITY EXPANSION ENVIRONMENTAL ASSESSMENT  
GEOLOGICAL CROSS-SECTION A-A'

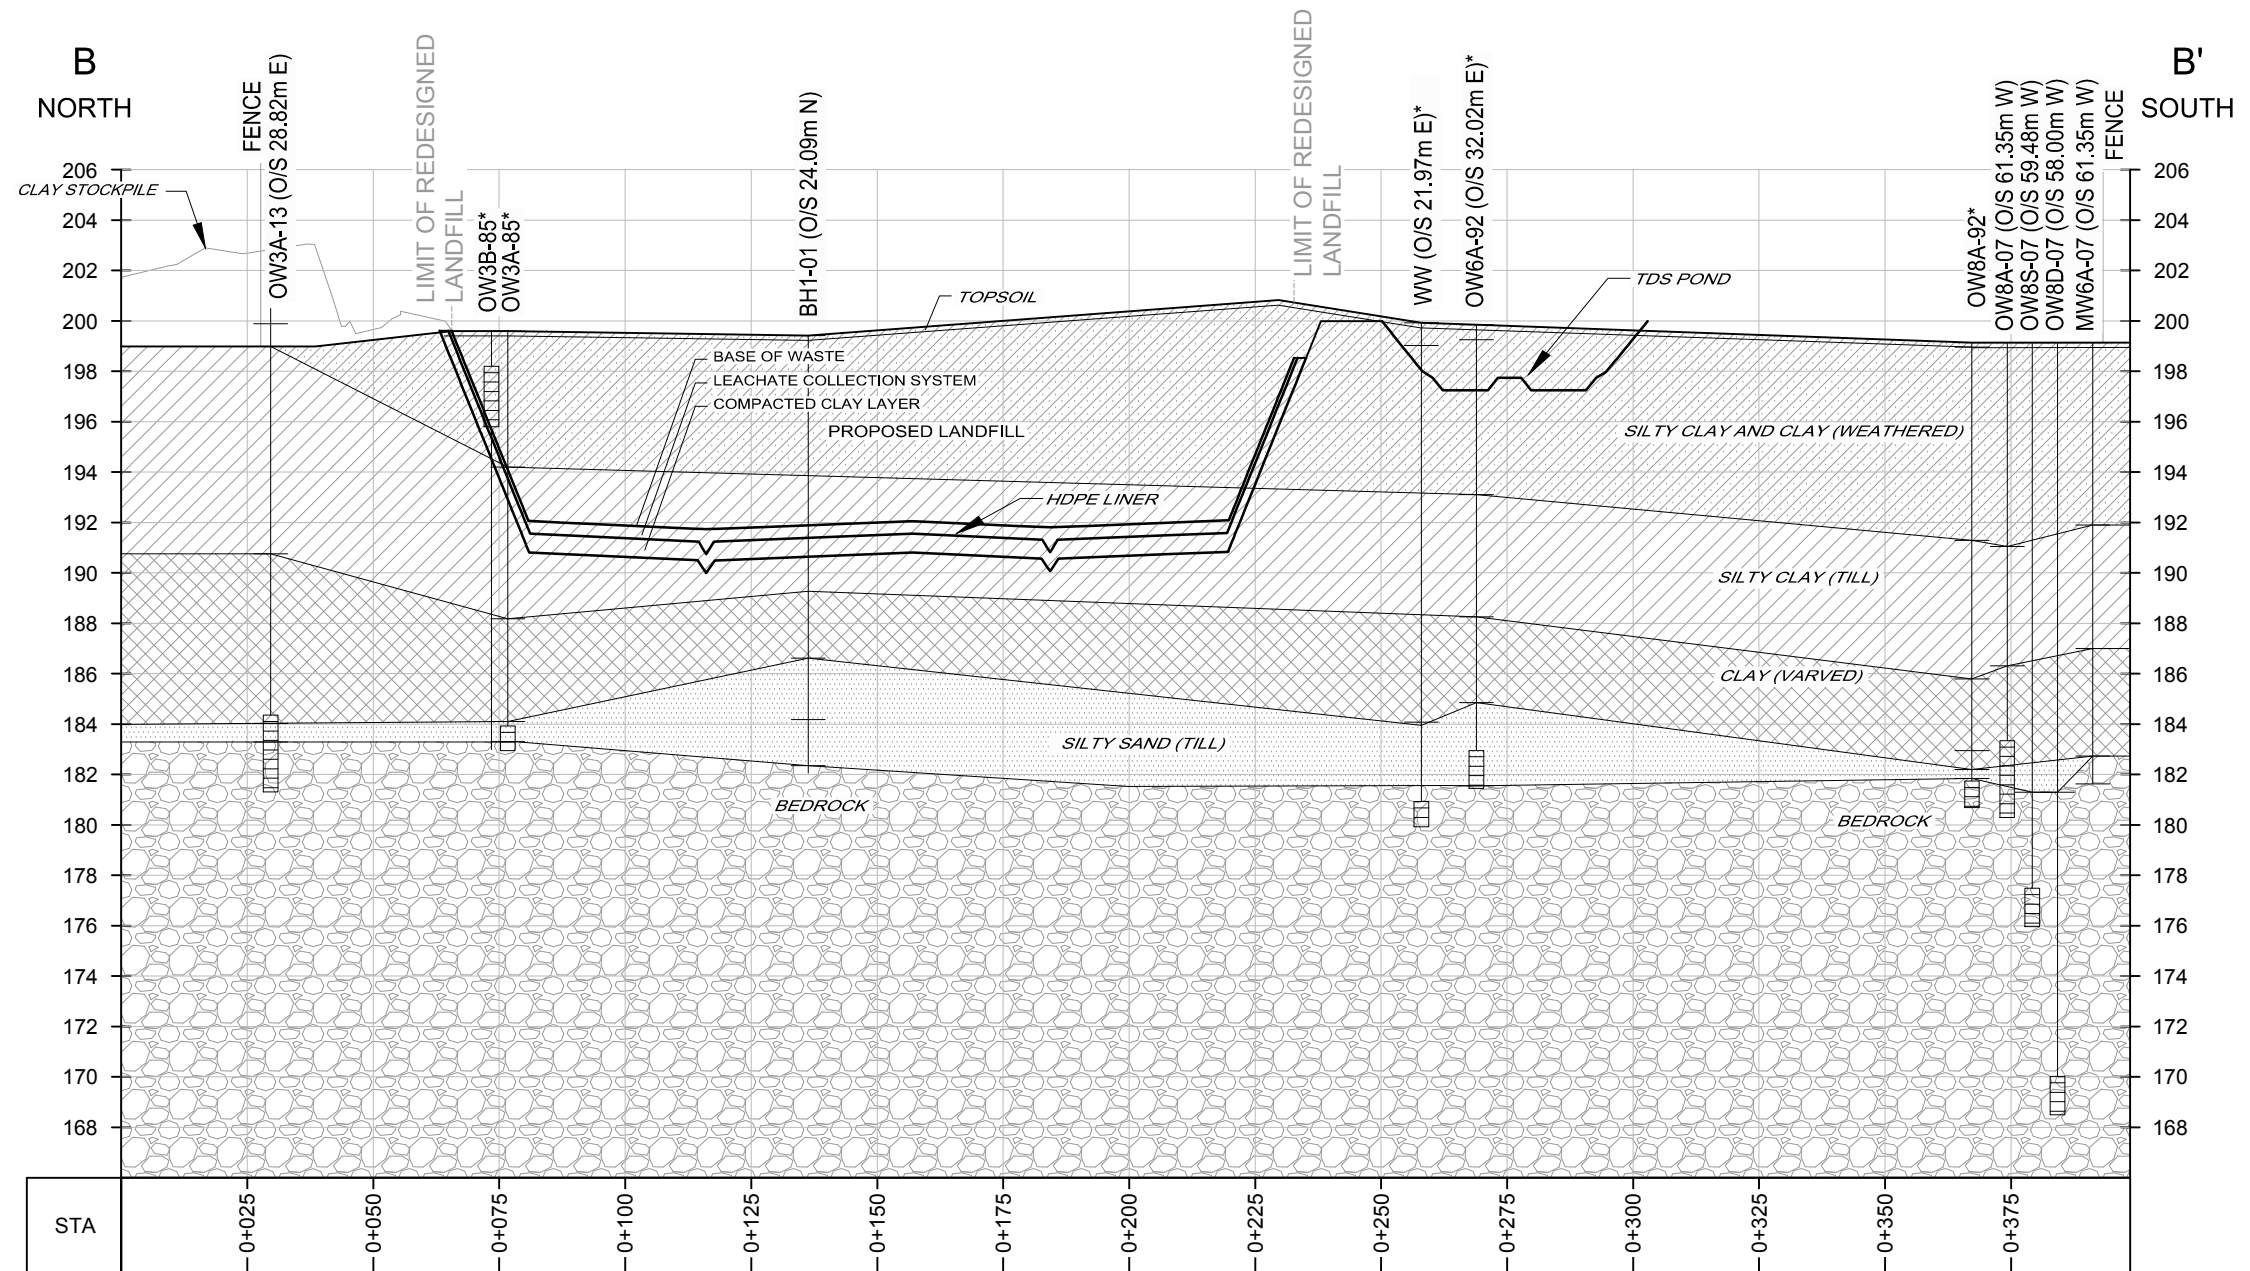
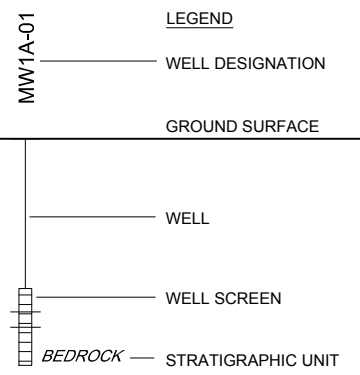
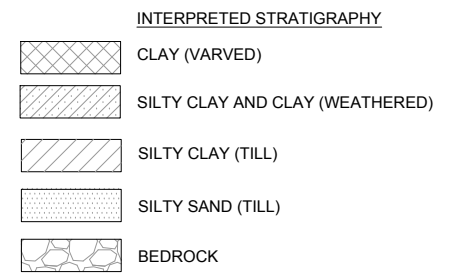
Figure 3

\* ABANDONED WELL - HISTORICAL DATA

BROOKS ROAD LANDFILL SITE  
Halimand County, Ontario  
GEOLOGY AND HYDROGEOLOGY ASSESSMENT REPORT  
VERTICAL CAPACITY EXPANSION ENVIRONMENTAL ASSESSMENT  
**GEOLOGICAL CROSS-SECTION B-B'**

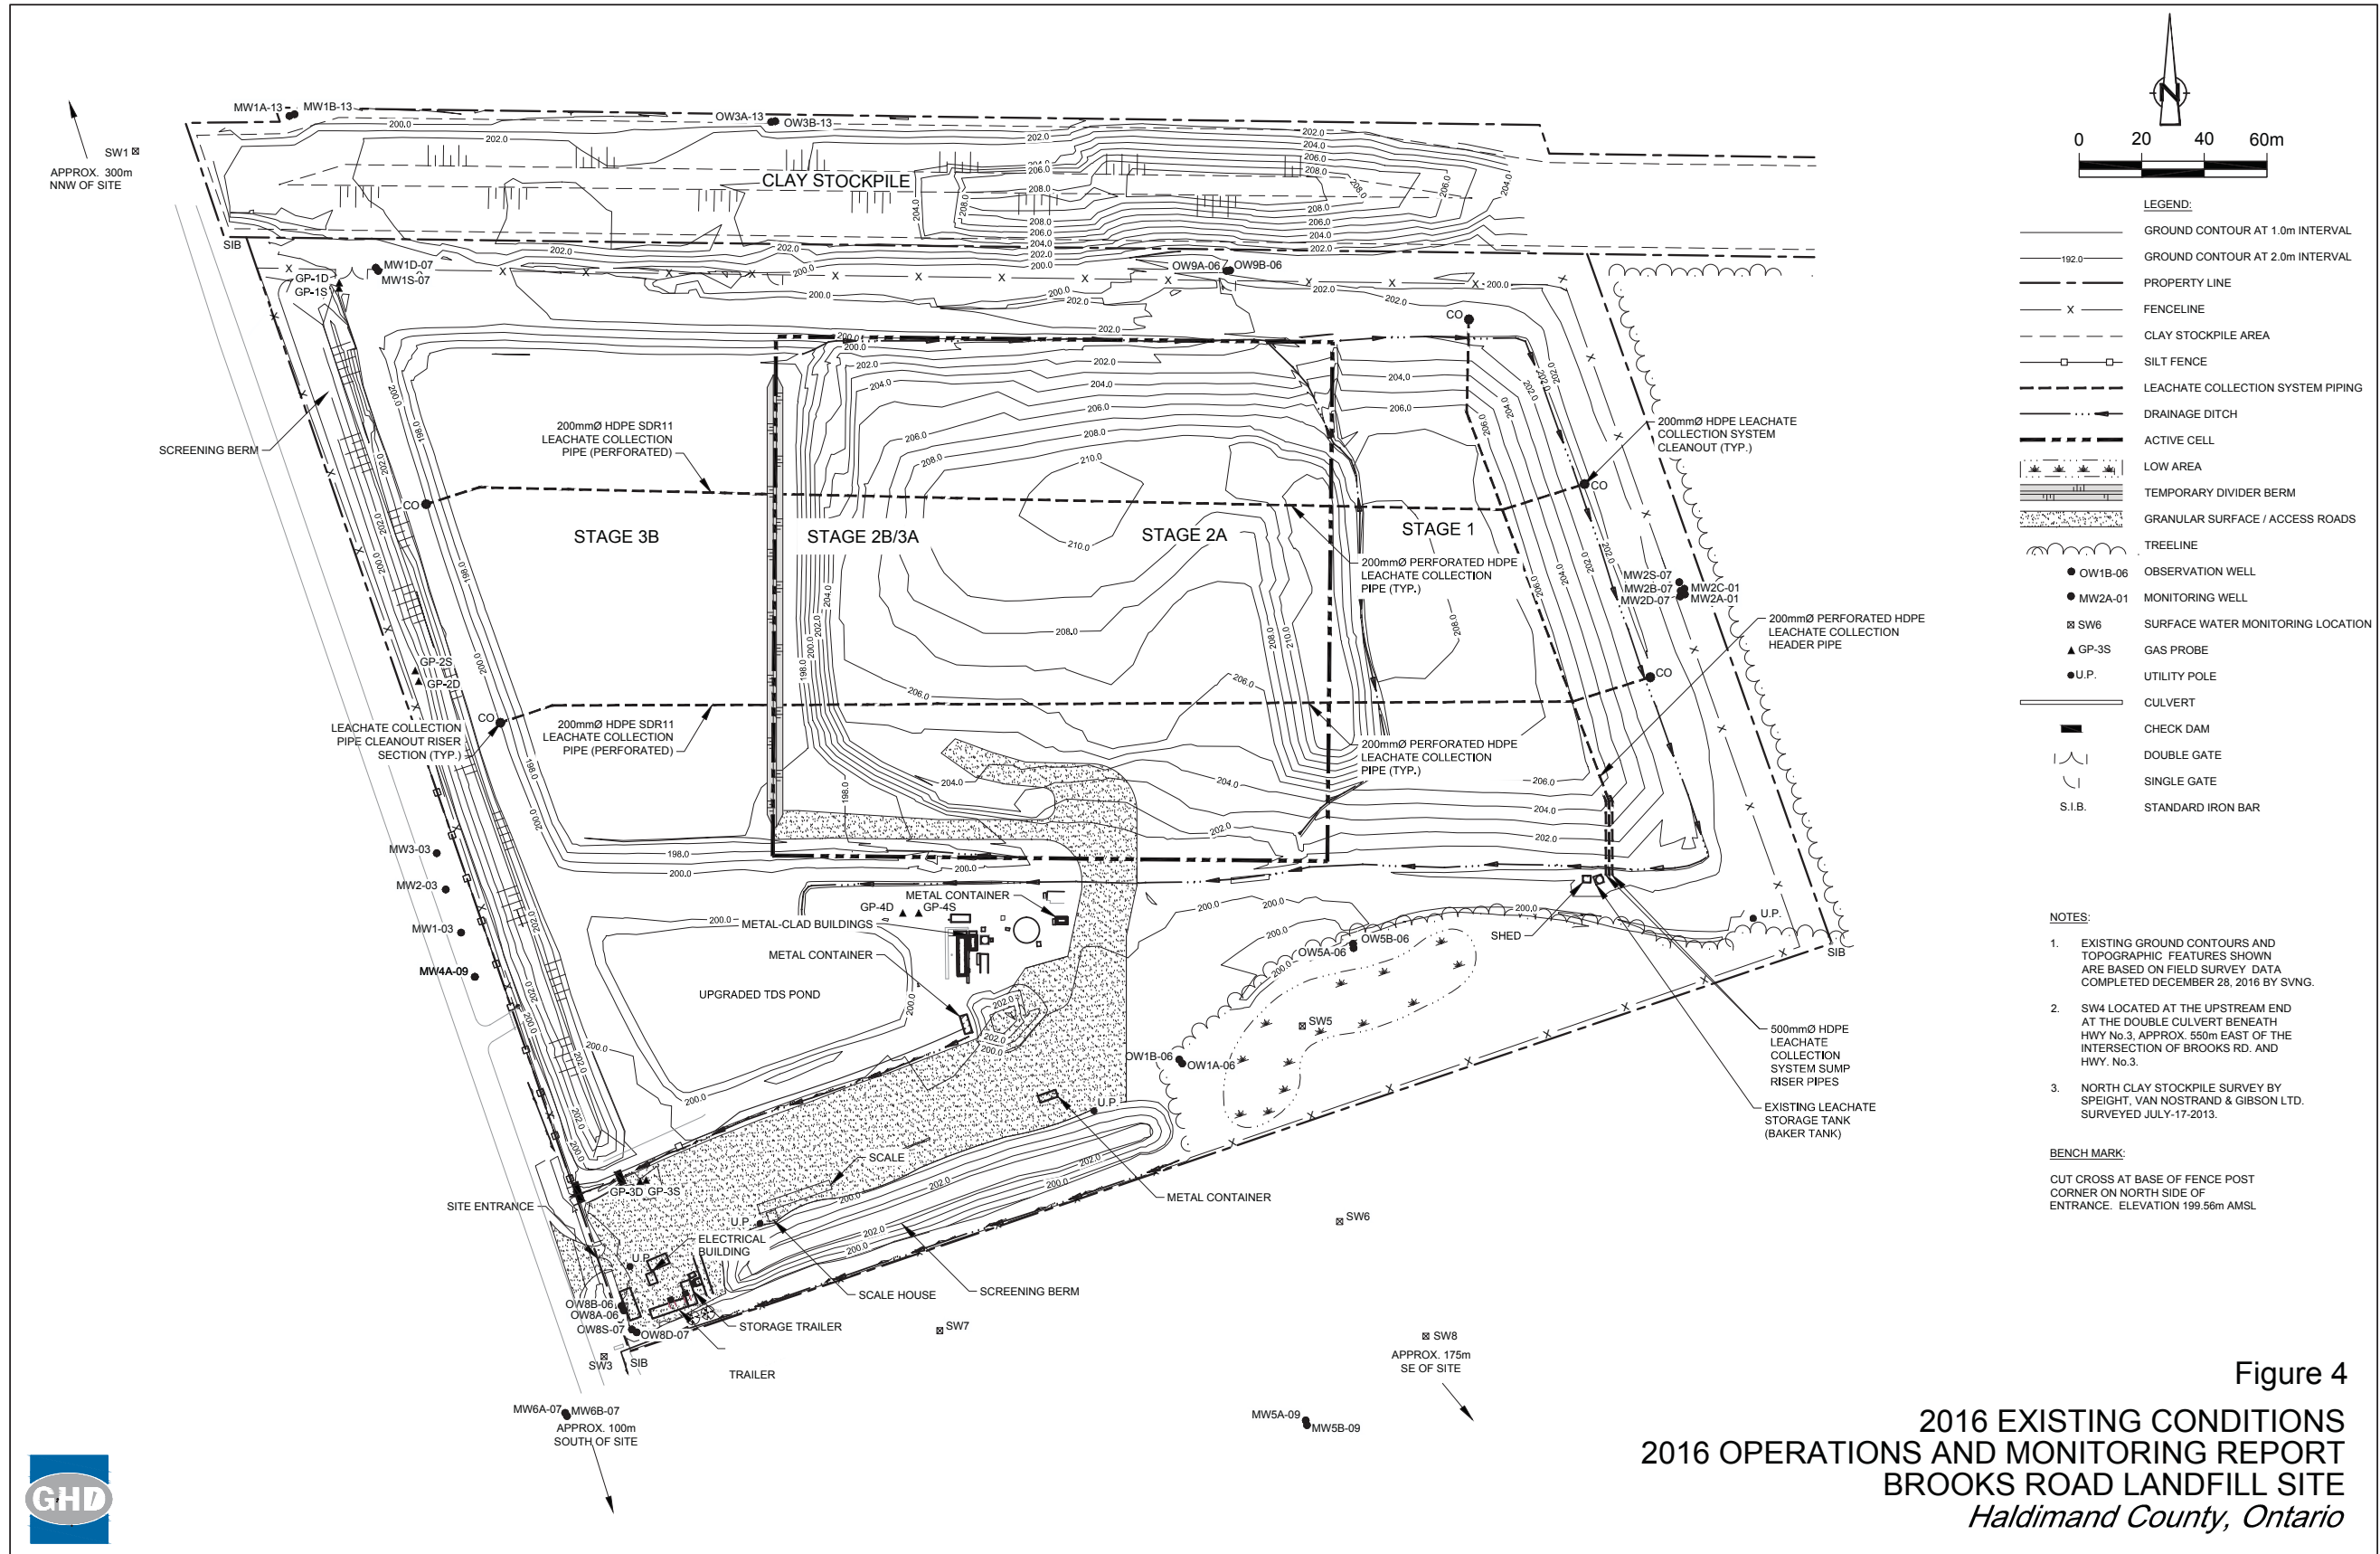
**Figure 4**  
**2016 EXISTING CONDITIONS**  
**2016 OPERATIONS AND MONITORING REPORT**  
**BROOKS ROAD LANDFILL SITE**  
*Haldimand County, Ontario*
